WEST INDIA GOODS STORE

Salem Maritime
National Historic Site

Historic Structure Report

HISTORIC STRUCTURE REPORT Architectural Data

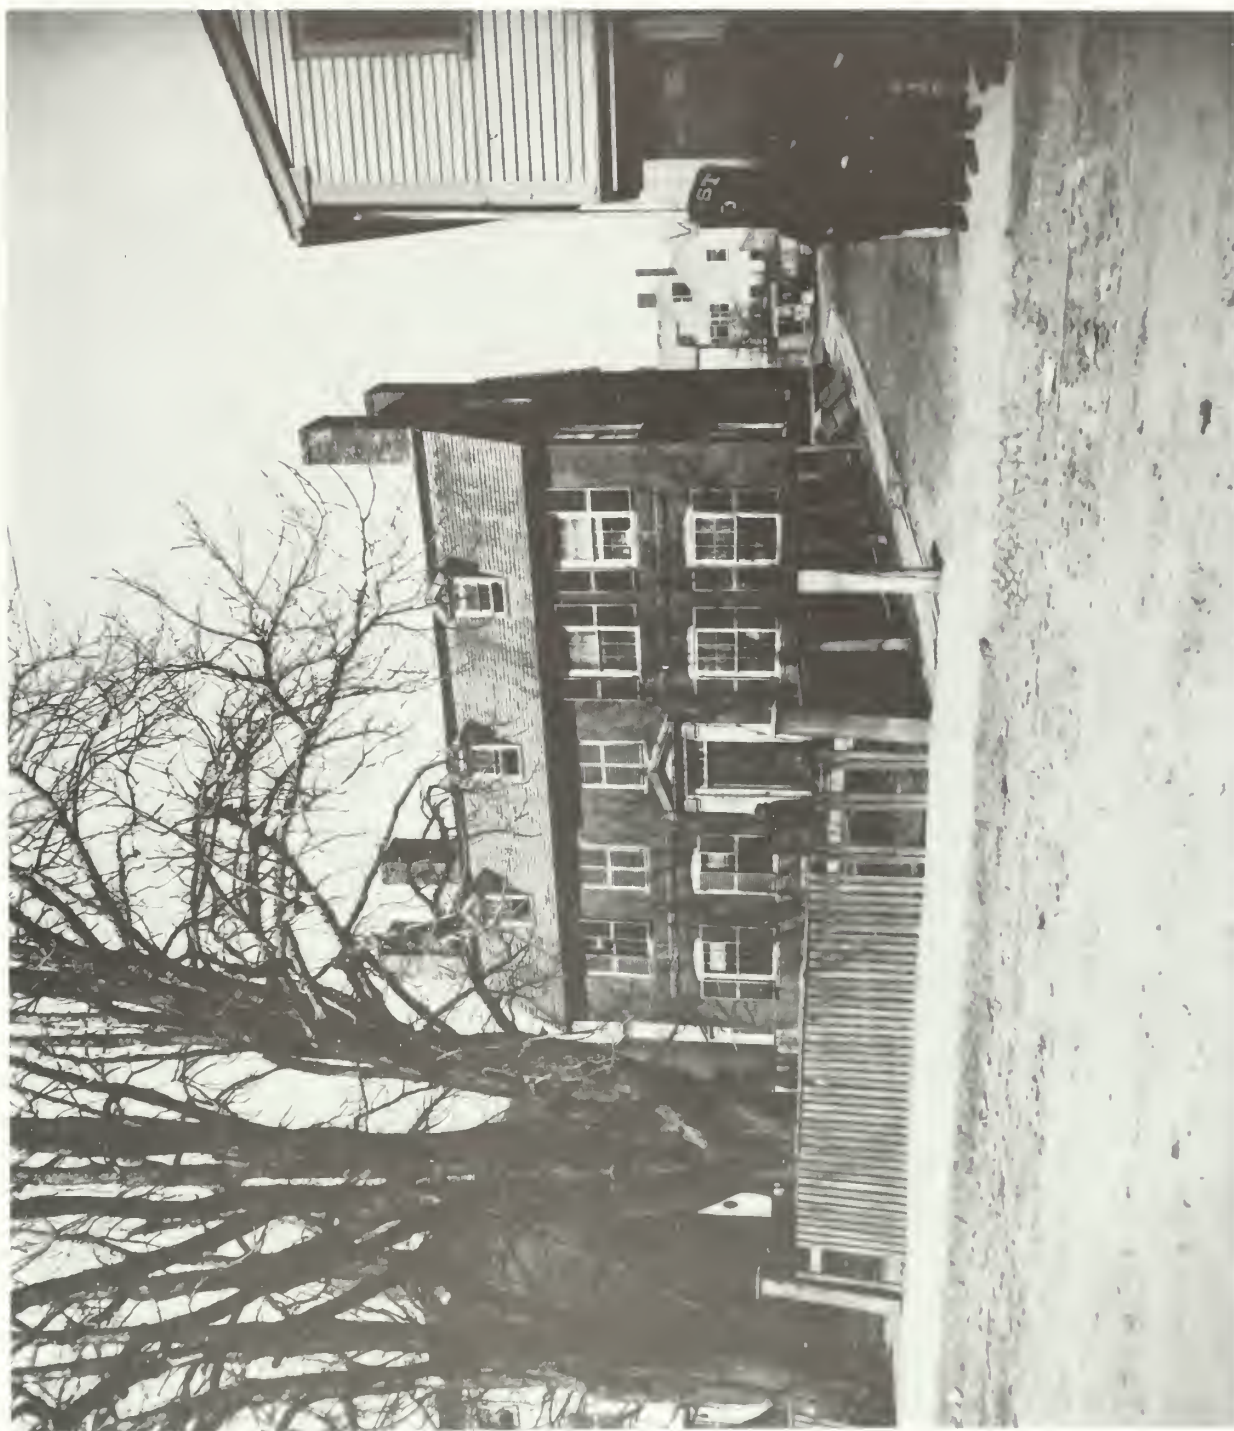
Figure 11. Derby-Prince-Ropes House and West India Goods Store, ca. 1891-1895.

A ca. 1891-1895 photograph (fig. 11) shows the west end of the south elevation. The foundation wall is hidden by persons standing in front of the structure, but one granite riser and one wooden riser to reach first-floor level are evident. At present, two granite and one wooden risers are necessary to reach the first-floor level.

The ca. 1891-1895 photograph (fig. 11) shows a doorway at the far west end of the south elevation. Evidence for the framing of the doorway being let into the girt was lost when the end of the girt was replaced.

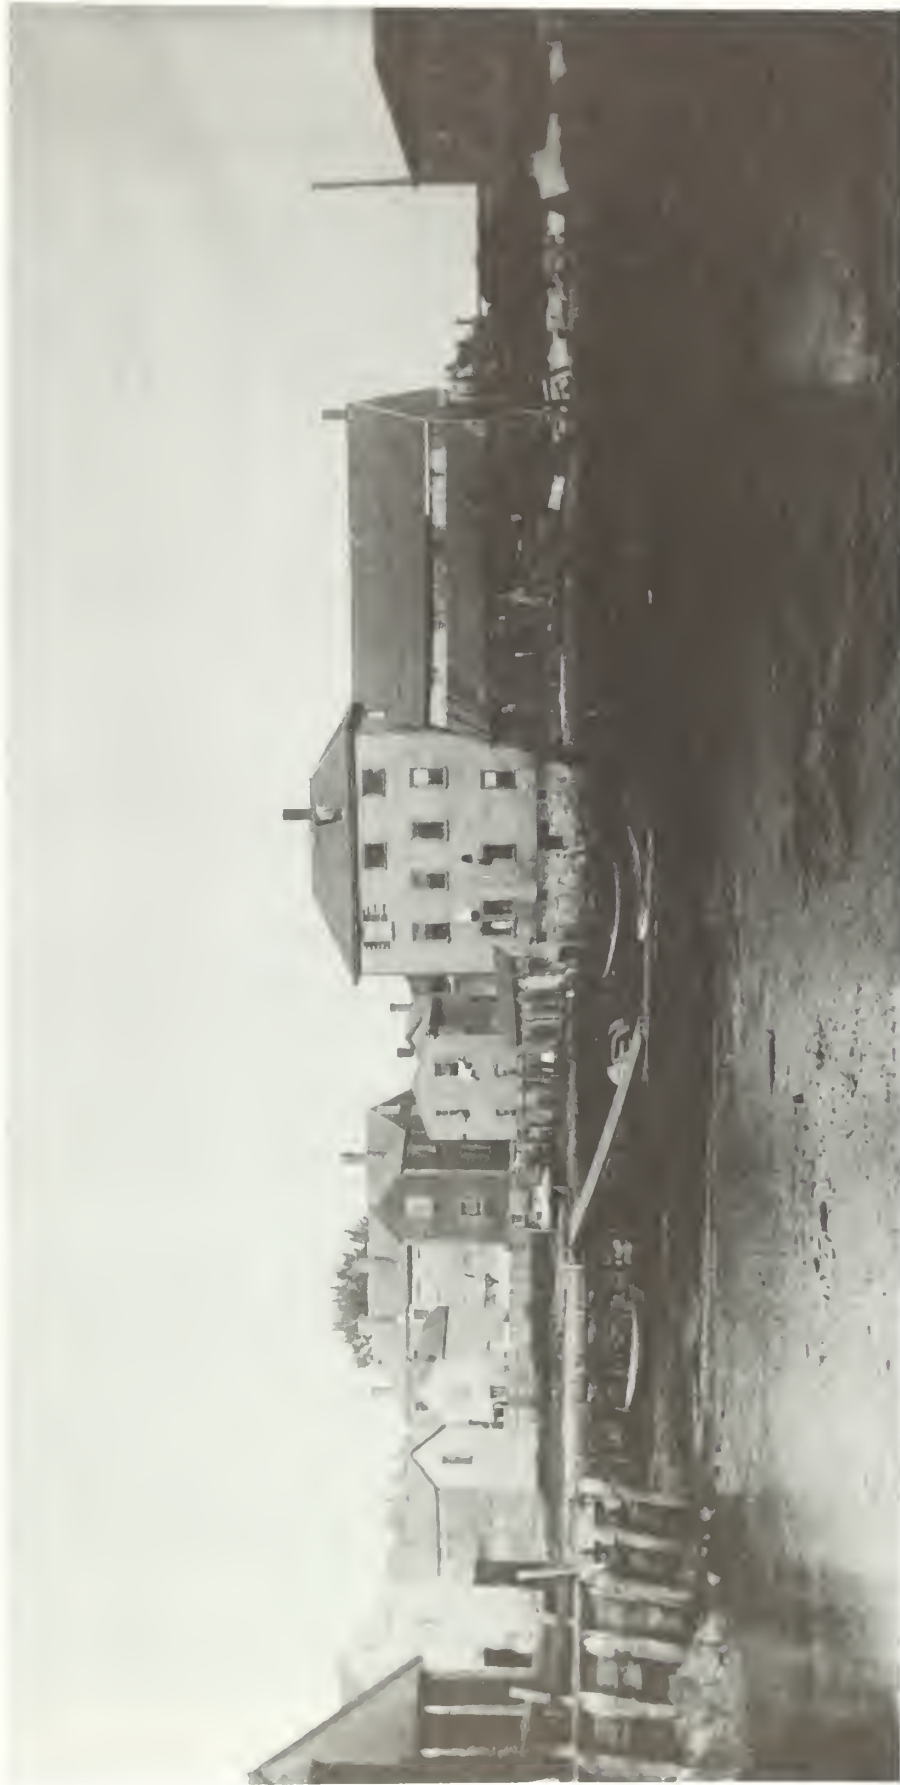
Figure 13. "Back of Derby Street, Salem, MA, ca. 1893," or "South River above the Bridge, before the Fire, Salem, MA," before June 1914.

Only one photograph (fig. 13) shows portions of a structure significantly similar to the West India Goods Store. There is question as to the date and location of the view: in the Peabody Essex Museum photograph file, the photo is noted as both "South River above the Bridge, before the fire, June, 1914" and "Back of Derby Street, 1893, photo taken by E.R. Thayer" (the same man who provided the sketch plan of Joseph Peabody's store/counting house). Query of the Peabody Museum as to which is the correct notation produced "South River... 1914." However, there are no utility lines in the photograph, even though Salem was electrified as early as 1909-1910, as evidenced by a Derby Street photograph taken at that time (fig. 14). (The pole and lines on the right side of the "South River" view were used to hoist the stones in the foreground.) At best, figure 13 is early but probably not historic.

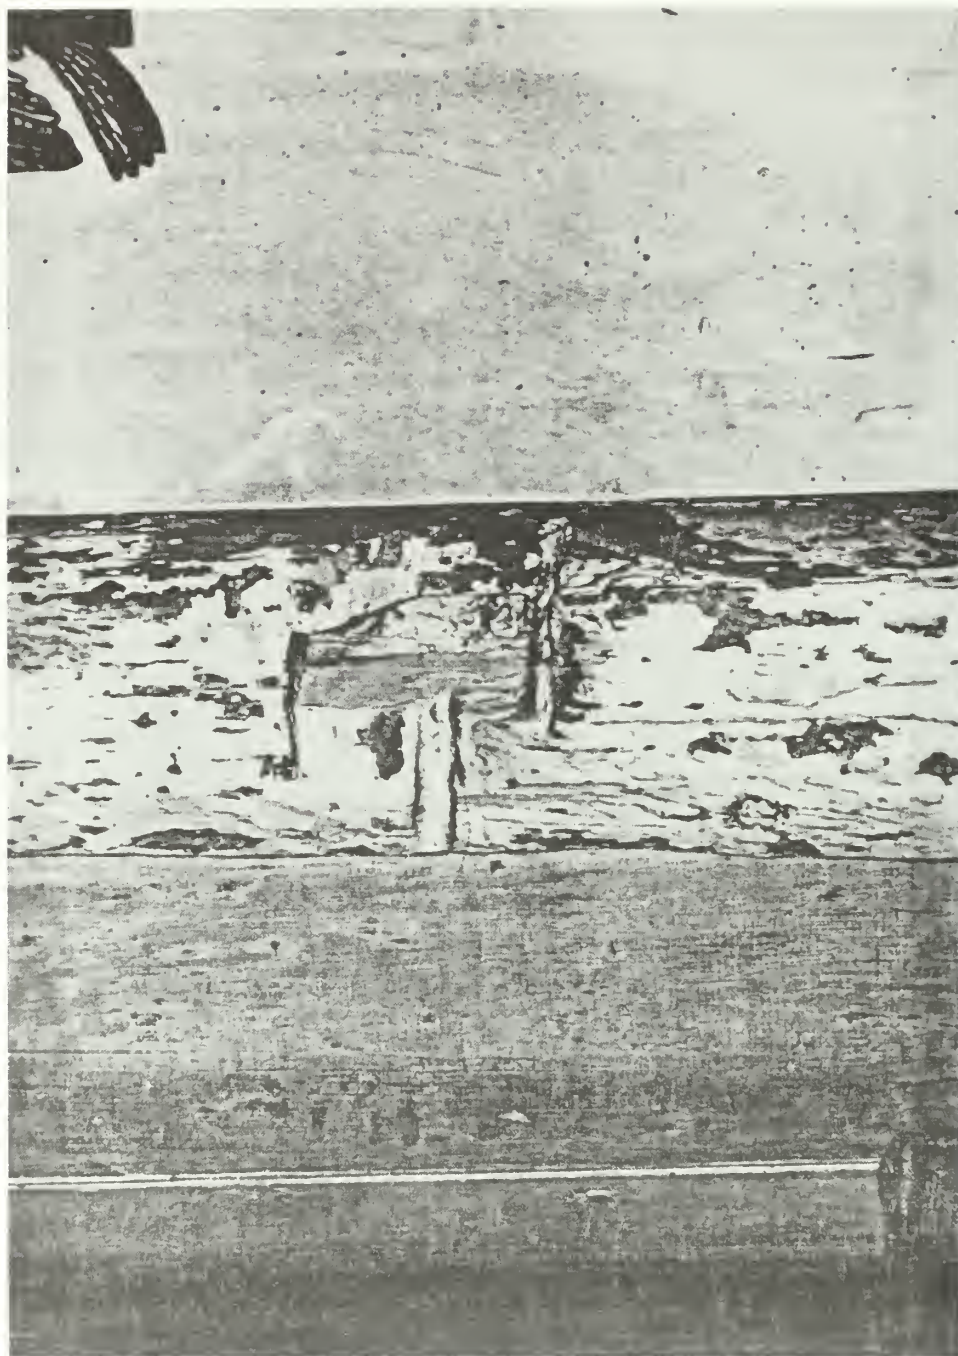
Figure 22. West India Goods Store: interior, second-story east wall, partition cut in post between bays A and B, June 1964.

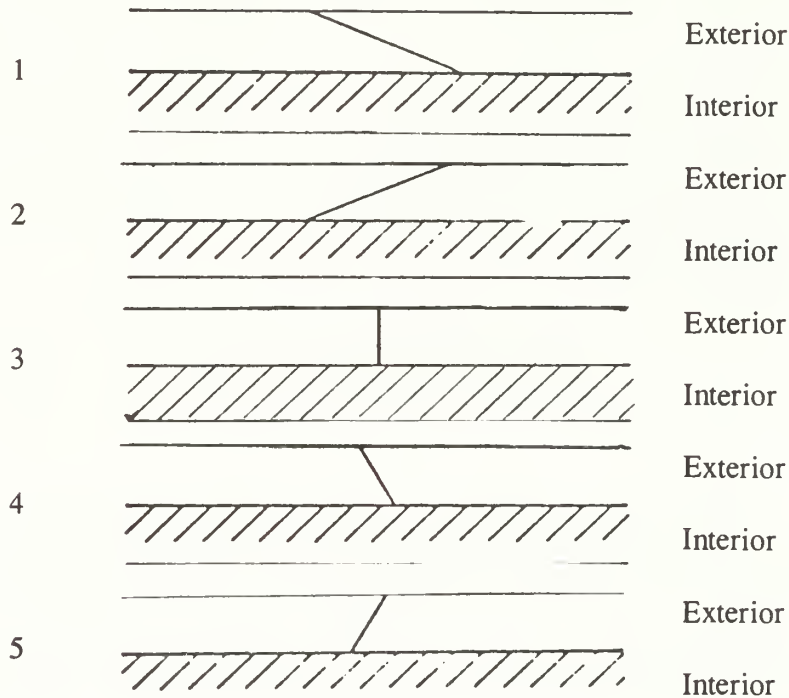
There are five types of extant clapboard joints evident on the West India Goods Store—four lap joints and a butt joint. These are illustrated and numbered below:

None can definitely be documented as historic. Joint 3 is probably nonhistoric. Joints 4 and 5 are also probably nonhistoric; these two joints are usually crudely made, and are probably imitative of joints 1 and 2. Also, in several places, one end of a clapboard is joined like 1 or 2, and the other end like 4 or 5. The Hawkes House at Salem Maritime NHS was completely re-sided ca. 1938-1939 with clapboards with joints 1 and 2 only, probably in close imitation of early 19th-century construction techniques. The Narbonne House, also at Salem Maritime NHS, has been substantially resided, but those clapboards documented as historic are joined like 1 or 2. From this evidence, joints 1 and 2 are called historic.

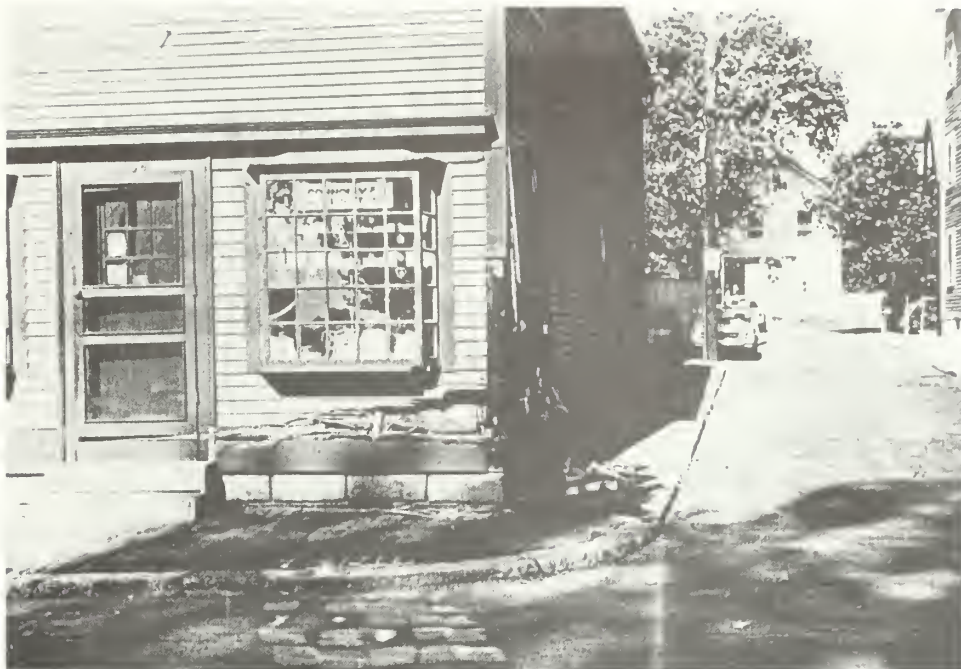
West India Goods Store showing damage caused by an automobile accident in November, 1983.

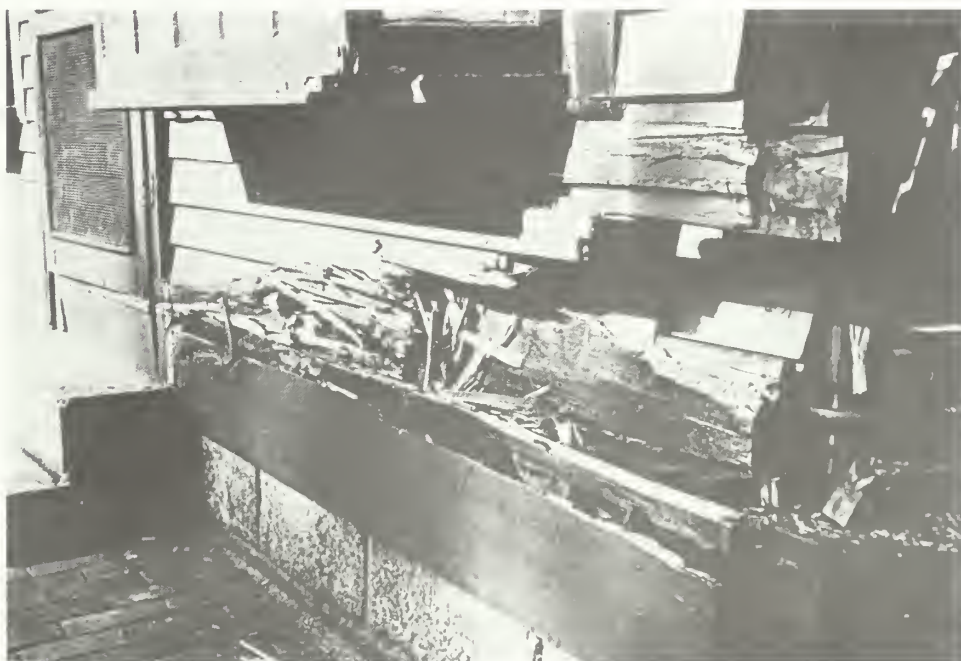
Damage at south east corner, WIGS, November, 1983.

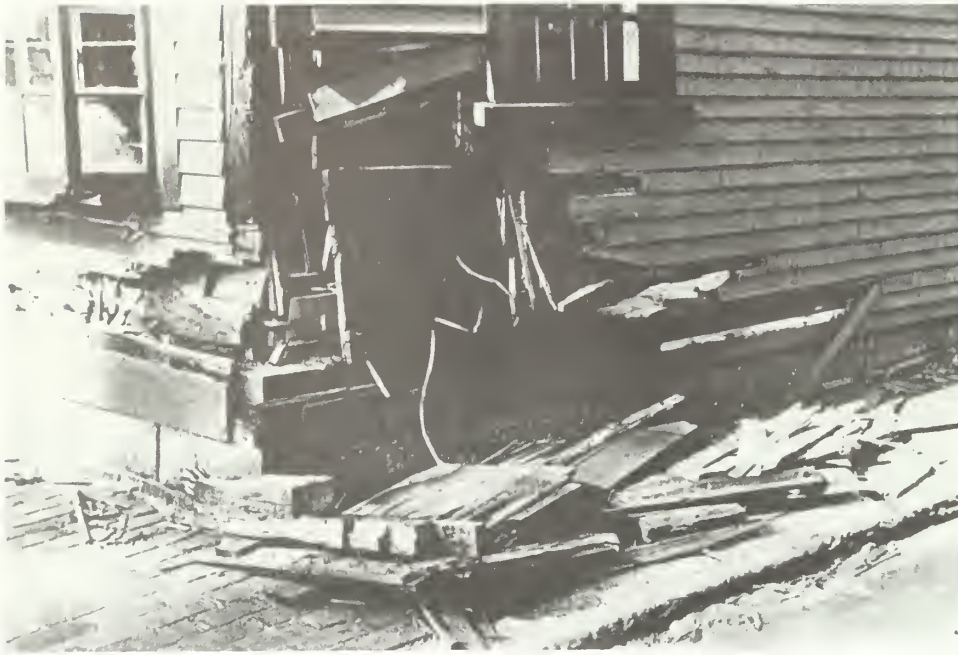
Damage at southeast corner, WIGS, November 1983.

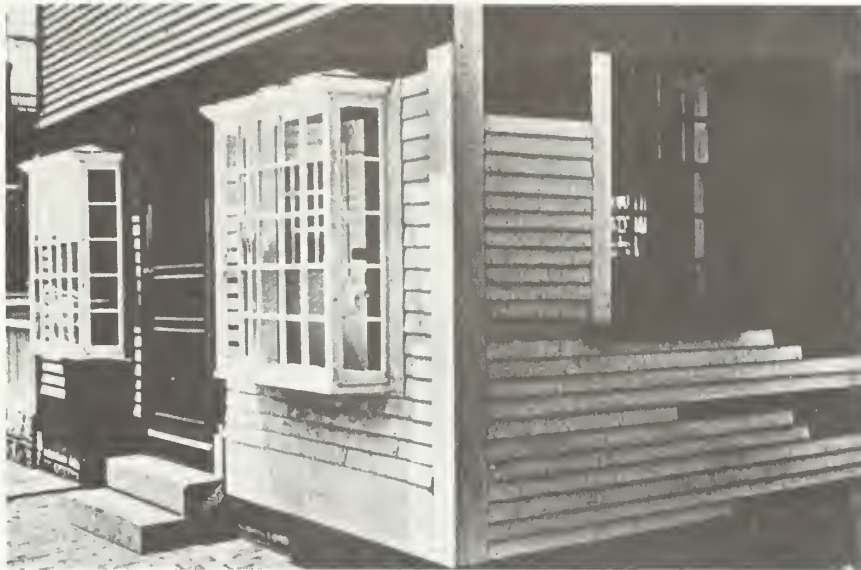
WIGS building after repair work was completed to the southwest corner in 1983. Both storefront windows were replaced at this time. The building was damaged in an automobile accident, November 1983.

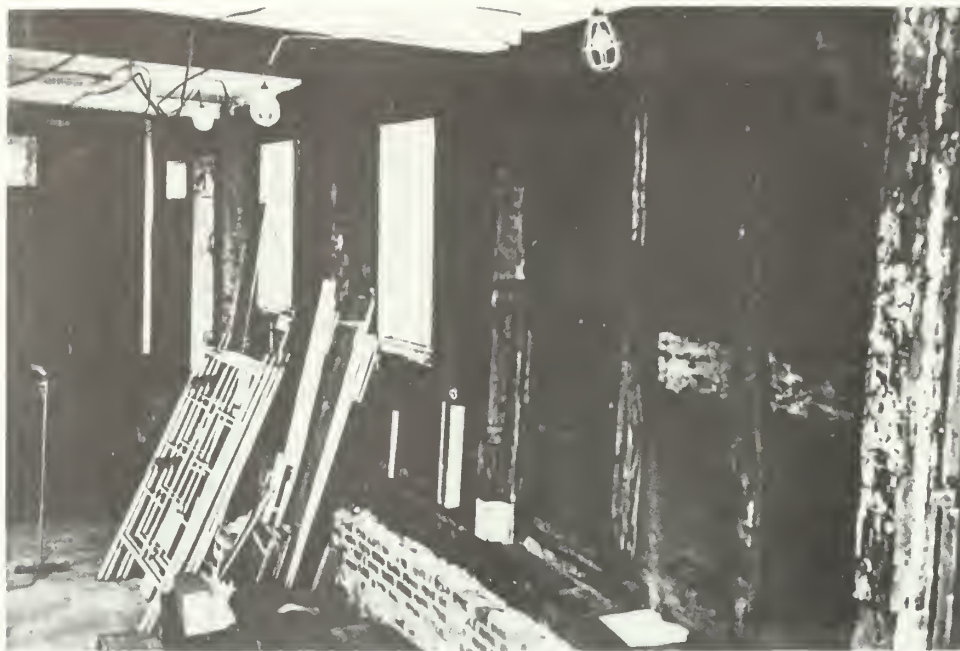
Interior of WIGS after joists and floor boards were removed from the first floor. View of east wall after interior wall boards were removed. Exterior wall sheathing was sprayed with an insecticide, "Dursban" which in turn was coated with an acrylic to prevent sublimation of the insecticide crystals.

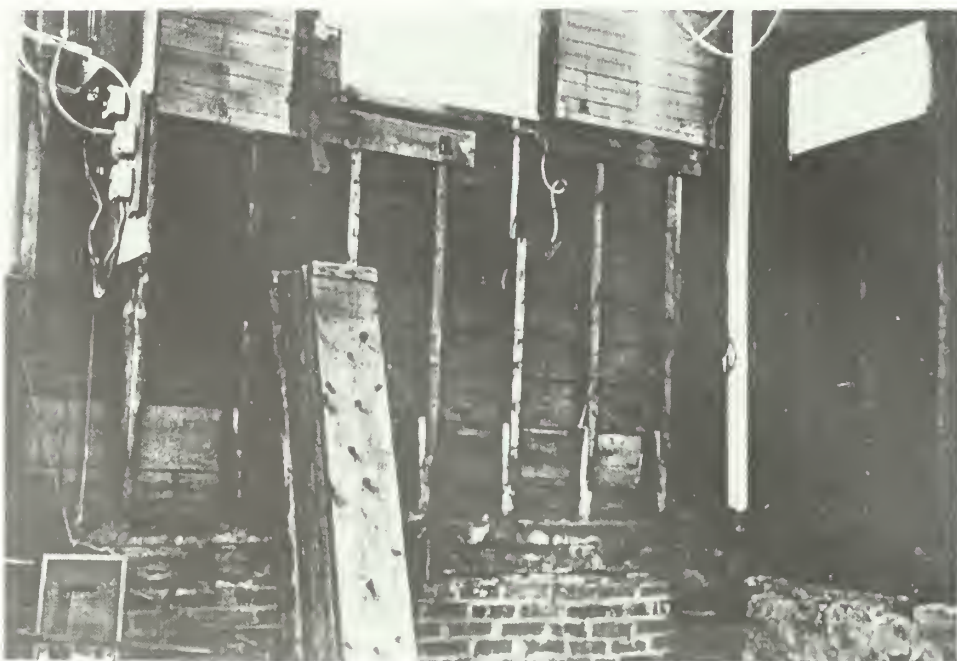
North east corner of WIGS, on the first floor showing reconstruction of end bay of building, probably dating from the restoration of ca. 1920.

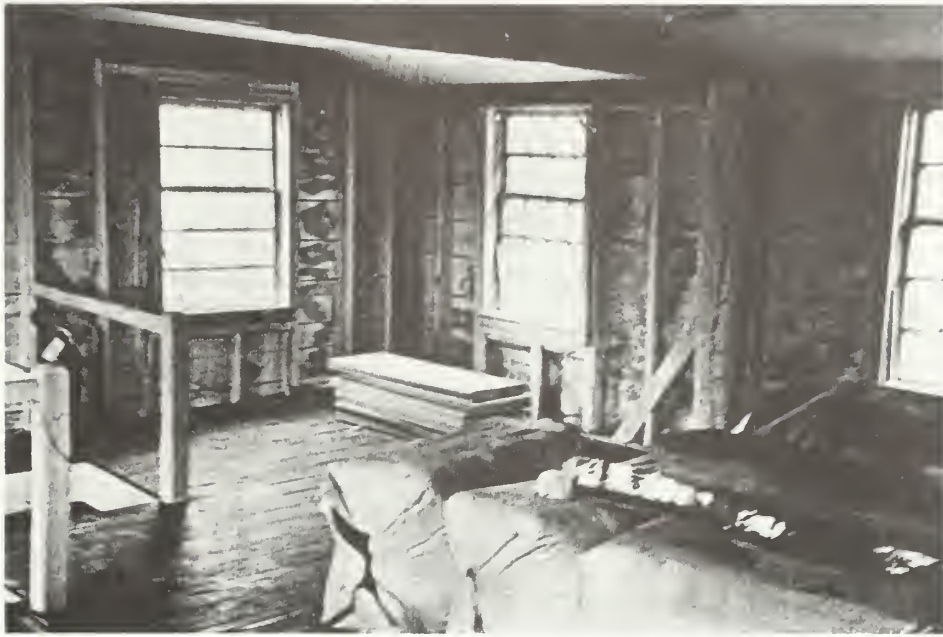
Second floor of WIGS, during rehabilitation work. The exterior wall boards were sprayed with an insecticide "Dursban" then coated over with a white latex paint. View of northeast corner of second floor.
